Power Quality Observations at a Light Industrial Site

Hamish Laird, *Student Member, IEEE*, Simon Round, *Member, IEEE*, Richard Duke, *Member, IEEE*
Alister Gardiner.

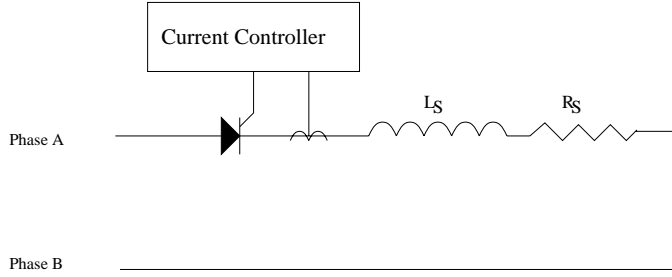
Figure 3. Induction Motor Heating Unit Circuit Diagram

The units are half-wave controlled rectifiers having only one thyristor and they produce DC, odd and even harmonics in the AC current. The lack of half-wave symmetry indicates that there are even harmonics and a DC component present.

The DC current has impact on transformer operation as it produces a DC MMF that will offset the magnetising hysteresis of the transformer core. If the offset is large enough to drive the core sufficiently into saturation the magnetising current will increase and this could cause transformer overheating and possibly failure. As the rectifiers are connected line to line, the current has non-zero sequence triplen harmonic components that propagate through a star-delta supply transformer. Such harmonic currents may cause resonance that would not be excited by zero sequence triplen harmonics (produced by balanced harmonic loads) which are blocked by a star-delta transformer. The impact of the motor

The induction motor heater unit current harmonics are large and the presence of even harmonics is unusual. The apparent lack of problems that the DC component of the heater current causes is perhaps fortuitous as the resulting transformer MMF offset could cause transformer damage through saturation. No such damage has occurred and the transformer operating temperature during the site survey was 38 C. The fact that the heater units operate only when the site load is low means any adverse transformer heating from saturation is offset by reduced heating due to the low load. Configuring the rectifiers to produce a half wave symmetric current waveform would eliminate the DC current produced by the induction motor heaters. One way to do this is to reverse the phase connection of one of the induction motor heaters. The two heater units would then conduct in opposite half cycles and together would produce a half-wave symmetric waveform. This would decrease the peak current and remove the even harmonic currents. The current waveform would however not be half-wave symmetric at all times as the heating units are on occasion operated separately. However the maximum level of DC current flowing in the transformer would be lowered as DC current would flow only when one heater was operating.
